# Non-Conformance Report

Executive non-conformance report for critical work-at-height safety breach and contractor control failure.

NCR ID  
NCR-20260610-175931996

| Item | Details | Item | Details |
|---|---|---|---|
| Time | 18:02 UTC | Site | XXX — Power Plant |

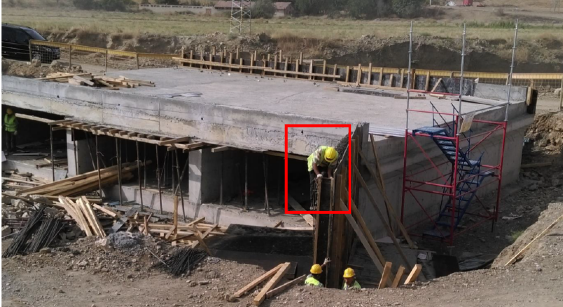
### PHOTO 1

Field Evidence Submitted by User — Following non-conformances observed during the site visit involving work performed by subcontractor DEMO Company. Worker working at height without 100% fall protection at office building construction area.

A worker is visible at height on or near vertical formwork/reinforcement adjacent to an open construction edge. No full-body harness, lanyard, secured anchorage, lifeline, edge protection, or certified work platform is clearly visible. The surrounding area includes uneven excavation, loose timber, rebar bundles, temporary formwork materials, and incomplete access control. Multiple workers appear present below the elevated work area, creating potential exposure to falling persons and dropped objects.

Following non conformances observed during the site visit which the work performed by subcontractor DEMO Company Worker working at height without %100 fall protection at office building construction area.

A contractor worker was observed performing work at height without verified 100% fall protection in an active construction zone with additional exposure to falls, dropped objects, poor housekeeping, and inadequate work-at-height controls.

- In Photo 1, a worker is positioned at elevation near vertical formwork/reinforcement and an open structural edge. There is no visible full-body harness, double lanyard, lifeline, certified anchorage, guardrail protection, or properly designed working platform. Workers below are potentially exposed to dropped objects and fall-related secondary impacts.
- In Photo 2, a worker is using a handmade wooden ladder as an access and work-positioning method. The ladder appears non-standard and unsuitable for controlled construction work at height. It is not visibly secured, tagged, inspected, or stabilized. The worker is not visibly tied off and is working from an unstable position.

| Priority | Action | Responsible | Due |
|---|---|---|---|
| Immediate | Stop all work-at-height activities in the affected office building construction area until controls are verified. | Site Management / HSE / Contractor Supervisor | Immediate |
| Immediate | Confirm all workers performing work at height have full-body harnesses, compatible lanyards, certified anchorage, or collective protection before resuming work. | Contractor Supervisor / HSE | Immediate |
| Immediate | Establish an exclusion zone below elevated work areas to protect personnel from falling persons, tools, and materials. | Construction Supervisor | Immediate |

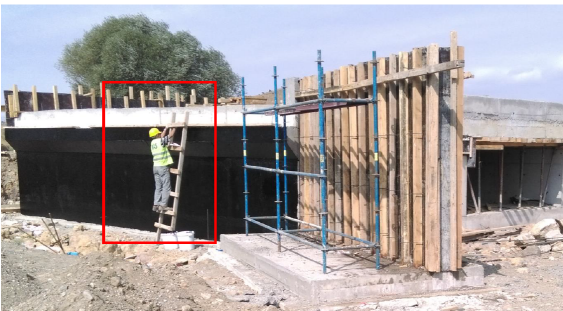
### PHOTO 2

Field Evidence Submitted by User — A handmade wooden ladder is used and without fall protection by the DEMO Company worker at the office building construction site area.

A worker is standing on a handmade wooden ladder positioned against a concrete structure. The ladder does not appear to be an industrial-rated access ladder and no visible securing, stabilizing, footing control, inspection tag, or fall-arrest system is present. The worker appears to be using one hand to perform work while elevated, creating reduced stability. Nearby scaffold elements and formwork are present, but the ladder is being used instead of a controlled access platform.

A handmade wooden ladder is used and without fall protection by the DEMO company worker at the office building construction site area.

A contractor worker used a non-certified handmade wooden ladder for elevated work without fall protection, indicating unsafe access selection, inadequate supervision, and failure to control work-at-height risk.

| Priority | Action | Responsible | Due |
|---|---|---|---|
| Immediate | Remove the handmade wooden ladder from service and quarantine it to prevent further use. | Contractor Supervisor / HSE | Immediate |

- Photographic evidence showing compliant access equipment replacing the handmade wooden ladder.
- Confirmation that the handmade ladder has been removed, destroyed, or permanently taken out of service.
