# SAFEASPECT AI SAFETY COMPLIANCE & DISCIPLINARY ACTION REPORT

## SECTION 1: INCIDENT SUMMARY

| Report ID | Date | Time | Incident Type | Severity | Status |
|---|---|---|---|---|---|
| VIO-EN-20261016-1<br>10655379 | 2026-10-16 | 09:06 | Working-at-height<br>control breach | Critical | Open—immediate<br>controls required |

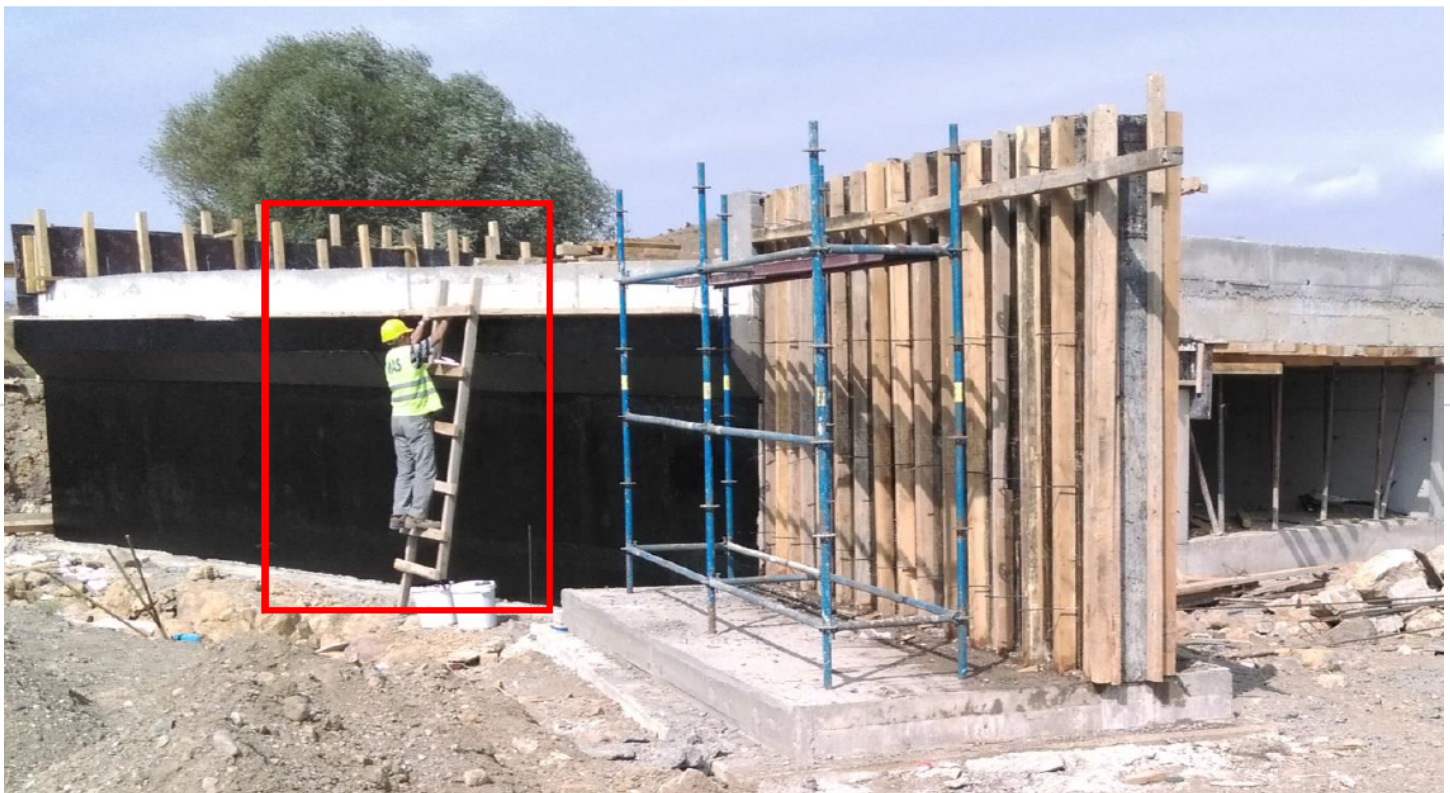
### ## 1. Photo 1—Construction Scene

*Worker using an unsecured leaning ladder beside an unfinished concrete structure*

1. A worker is positioned on a portable leaning ladder against an unfinished concrete structure.
2. The worker appears to be several ladder rungs above ground, consistent with the reported working height of approximately 2–2.5 metres.

3. No body harness, lanyard, lifeline, or secured anchorage is visible.
4. No guarded working platform is provided at the worker's position.
5. The worker appears to be reaching or working near the top of the ladder, which may reduce stable three-point contact.

6. The ladder does not visibly extend above a landing to provide a secure handhold; it appears to be used as a work station rather than solely for access.

7. Ladder restraint at the top and bottom is not visible. No second person is visibly footing or stabilizing the ladder.
8. The ladder feet appear to rest on uneven ground containing soil, stones, rubble, and construction debris.

9. A hard concrete or compacted surface and construction debris are present within the likely fall zone.
10. Buckets or containers are located near the ladder base and may introduce obstruction or trip exposure.

11. A partial scaffold frame is visible nearby, but it does not appear decked or configured as an accessible, complete working platform.

12. Timber formwork and unfinished structural elements are present. No exclusion zone or barricade is visible around the elevated work.
13. The worker visibly wears a hard hat and high-visibility vest. Safety footwear appears likely but cannot be conclusively verified. Gloves and eye protection cannot be reliably confirmed from the image.

The photograph supports failures in work-at-height planning, selection of access equipment, ladder setup, fall protection, housekeeping, and supervisory verification. Corrective measures must therefore extend beyond instructing the worker to wear a harness. The task should be redesigned around a properly inspected scaffold, mobile work platform, or other suitable platform with collective edge protection wherever practicable.

Photo 1 materially supports the inspector's account of elevated work from a leaning ladder without visible fall protection. The image also identifies additional exposure factors: rough ladder footing, debris near the base, possible overreaching, no visible ladder restraint, no barricaded drop zone, and no complete work platform.

| No. | Required Action | Owner | Priority / Target |
|---|---|---|---|
| 1 | Stop the elevated task and prevent further ladder use under the observed conditions. | Site Supervisor / HSE | Immediate |
| 2 | Barricade the work and potential fall-object zone until controls are verified. | Site Supervisor | Immediate |
| 3 | Provide a compliant scaffold, mobile platform, or MEWP selected through a task-specific assessment. | Construction Manager | Before restart |
| 6 | Remove the ladder from use until it is inspected for condition, suitability, footing, angle, and securing arrangements. | Competent Person | Immediate |
| 7 | Clear rubble, buckets, and obstructions from the ladder base and access route. | Area Supervisor | Immediate |

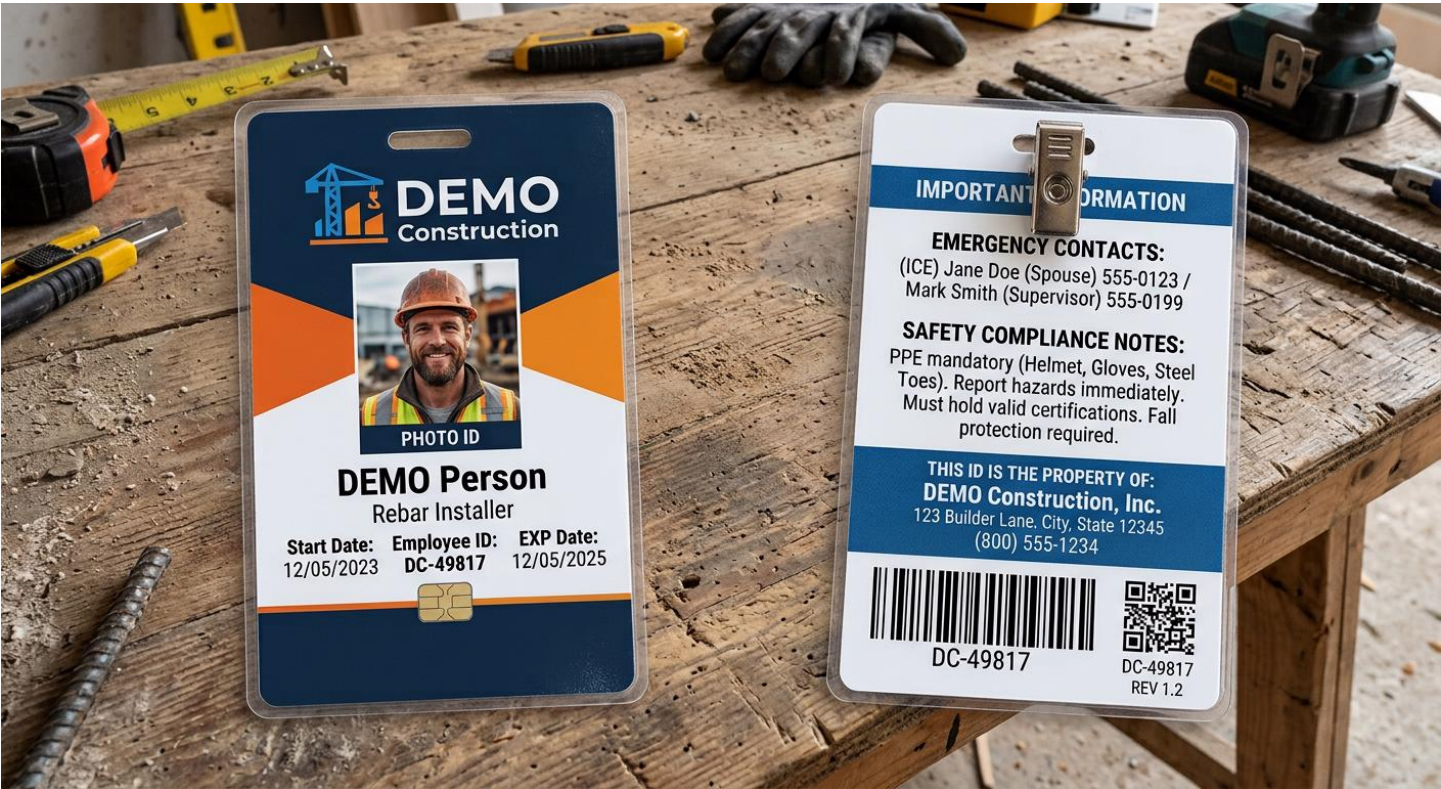
## 2. Document Image 1—Employee Identification Badge

Front and reverse of the reported employee identification badge

The badge explicitly states that fall protection is required and that the holder must maintain valid certifications. This supports the expectation that the employee had received, or should have received, basic notice of the fall-protection requirement. It does not, by itself, prove task-specific training, competency, understanding, or intentional disregard.

The expiry date shown is 12/05/2025, which predates the incident date of 2026-10-16 under either common date interpretation. The badge therefore appears expired. Continued access with an expired credential would indicate a separate access-control and administrative assurance failure requiring review by Security, HSE, HR, and contractor management.

- Suspend reliance on the displayed badge until its validity is confirmed.
- Audit site access records and credential-expiry controls.
- Verify current working-at-height training, medical fitness where required, and competency.
- Reconcile the employer name on the badge with the contractor named in the case record.
- Confirm the photographed worker's identity independently before imposing employee-specific discipline.

| No. | Required Action | Owner | Priority / Target |
|---|---|---|---|
| 12 | Suspend and investigate the apparently expired badge; issue a valid credential only after eligibility is confirmed. | Security / HR | Immediate |
