Project DEMO-01 Industrial Fabrication Works.

SafeAspect AI - Incident Report (HSE-EN-20261014-113245111)

INCIDENT INVESTIGATION REPORT

Report Number: HSE-EN-20261014-113245111  
Investigation Status: Interim — technical cause not yet established  
Scenario Classification: Fictional demonstration  
Applicable Framework: OSHA-style incident investigation and ISO 45001 continual-improvement principles

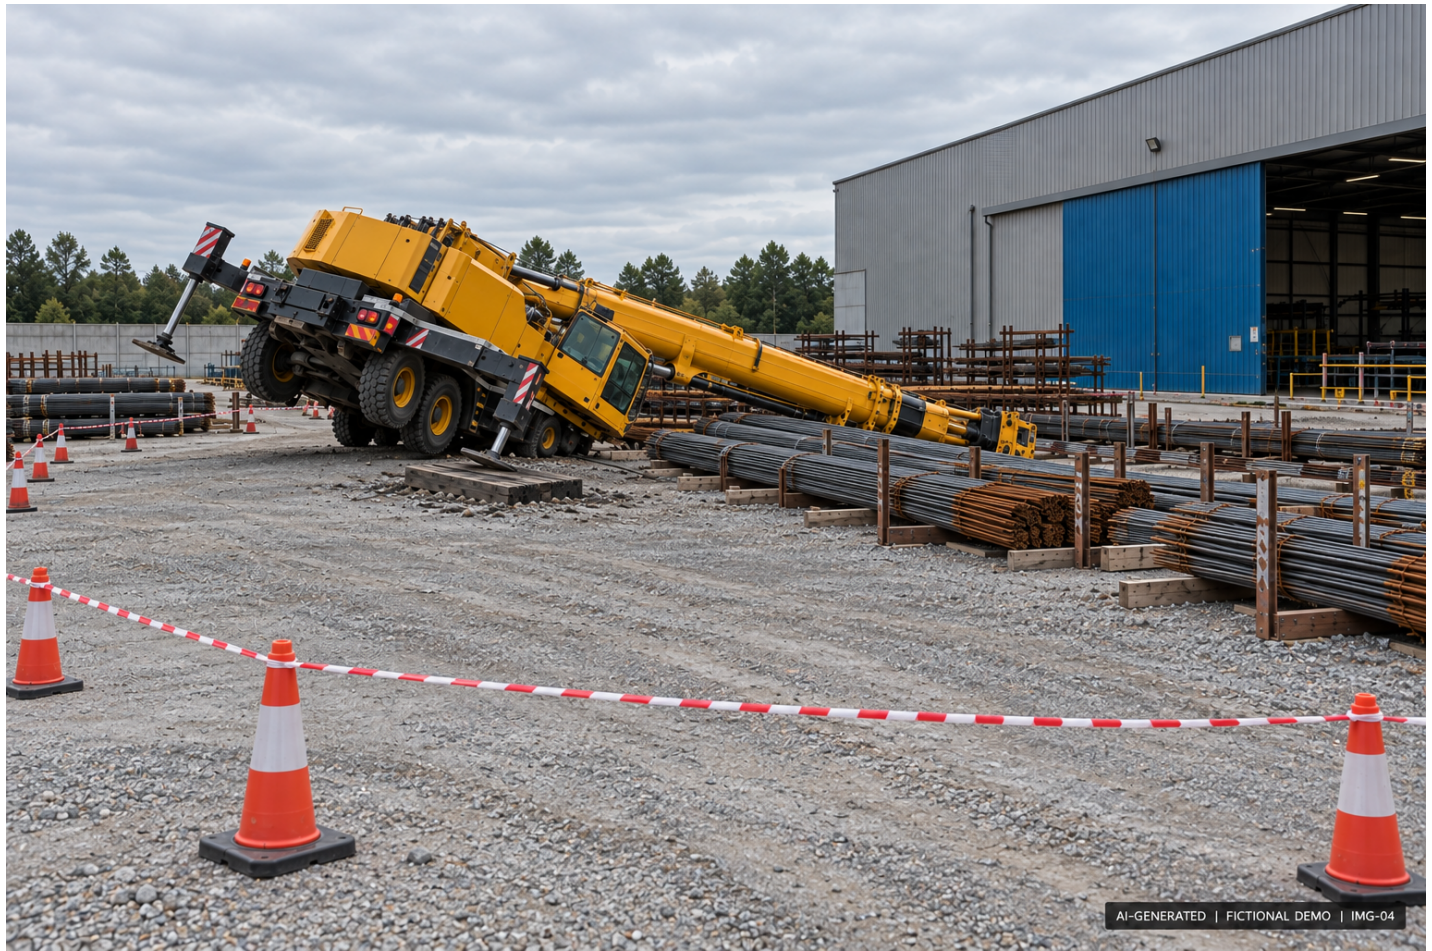
#### 1. Photo 1 — Wide Scene View

| Item | Attachment | Short Caption | Key Findings |
|---|---|---|---|
| 1 | Photo 1 — sa://m/0 | Wide view of overturned crane and rebar yard | Crane leaning toward load side; boom extended over stock; outriggers and timber mats visible; gravel surface; temporary cordon installed |

*Wide scene showing the crane leaning toward the rebar stock area*

- A yellow truck-mounted telescopic crane is shown leaning substantially toward the rebar stock area.
- The boom extends toward and over multiple bundles of reinforcement steel.

- Outriggers are visible, including supports bearing on timber mats placed over gravel.
- The ground is visibly uneven and contains loose aggregate. A timber mat near the crane appears displaced or depressed relative to the surrounding surface, although the image cannot establish when that condition developed.

- The carrier's wheels on one side appear elevated or unloaded, consistent with a major loss of stability.
- Red-and-white barrier tape and traffic cones form a temporary exclusion zone in the foreground and around parts of the scene.

- No personnel are visible; therefore, PPE compliance, positioning, and exposure at the time of the event cannot be assessed from this image.
- No obvious smoke, fire, or major fluid pool is visible.

Causal relevance: The image supports the confirmed outcome of overturn toward the load side and identifies ground support, outrigger loading, crane configuration, and load moment as necessary lines of inquiry. It does not establish the initiating mechanism.

| Factor | Finding | Evidence Basis | Confidence |
|---|---|---|---|
| Possible ground movement | Disturbed gravel and a depressed/displaced mat were reported or visible | Witness statement and Photo 1 | Medium; sequence unknown |

Action linkage: Preserve and survey the support positions; inspect the ground and mats; reconstruct crane geometry; verify load-chart capacity; and prohibit recovery until an engineered plan is approved.

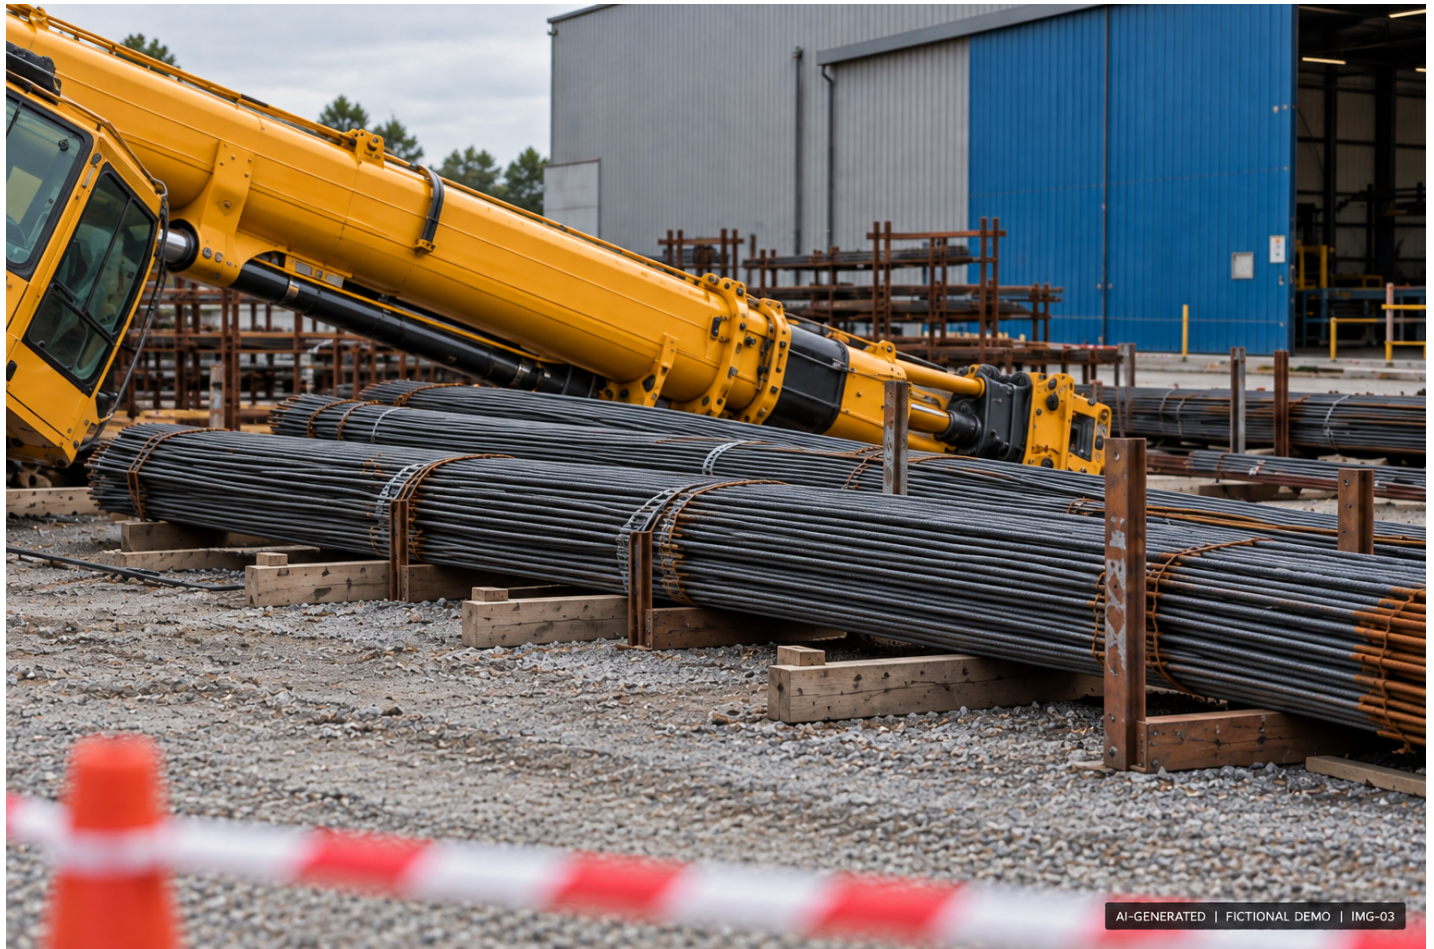
### 3. Photo 2 — Boom and Load Area

| Item | Attachment | Short Caption | Key Findings |
|---|---|---|---|
| 3 | Photo 2 — sa://m/2 | Close view of boom and rebar bundles | Boom resting across or immediately above bundled rebar; gravel and timber dunnage visible; post-event contact and stored-material hazards evident |

*Close view of the crane boom among bundled reinforcement steel*

- The telescopic boom is positioned across or immediately above multiple rebar bundles.
- The bundles remain banded and supported on timber dunnage within steel storage frames.
- The boom’s proximity to the bundles indicates potential impact loading and secondary structural damage.

- Loose gravel and irregular ground are visible around the stock supports.
- Rebar ends and steel storage frames present puncture, cut, strike, and access hazards during inspection or recovery.
- Temporary barrier tape is visible in the foreground, but the photograph does not establish whether a complete rigid exclusion zone was maintained.
- No personnel are visible, so PPE and worker positioning cannot be evaluated.
- No visible fire or substantial liquid release is apparent.
- The image is marked “AI-GENERATED | FICTIONAL DEMO.”

Causal relevance: The photograph confirms the final relationship between the boom and stored load but does not establish whether the bundles fully cleared their supports or their exact suspended mass at the onset of instability.

| Factor | Finding | Evidence Basis | Confidence |
|---|---|---|---|
| Stored-material interaction | Boom came to rest among rebar bundles and frames | Photos 1 and 2 | High |

Action linkage: Treat the boom, rigging, and rebar as potentially stored-energy hazards; prohibit entry beneath or beside the equipment; and use an engineered stabilization and recovery sequence.
